PD01-0361-13

# *Discovery on Wheels*

## **ISO-CART™ Gamma Spectrometer System**

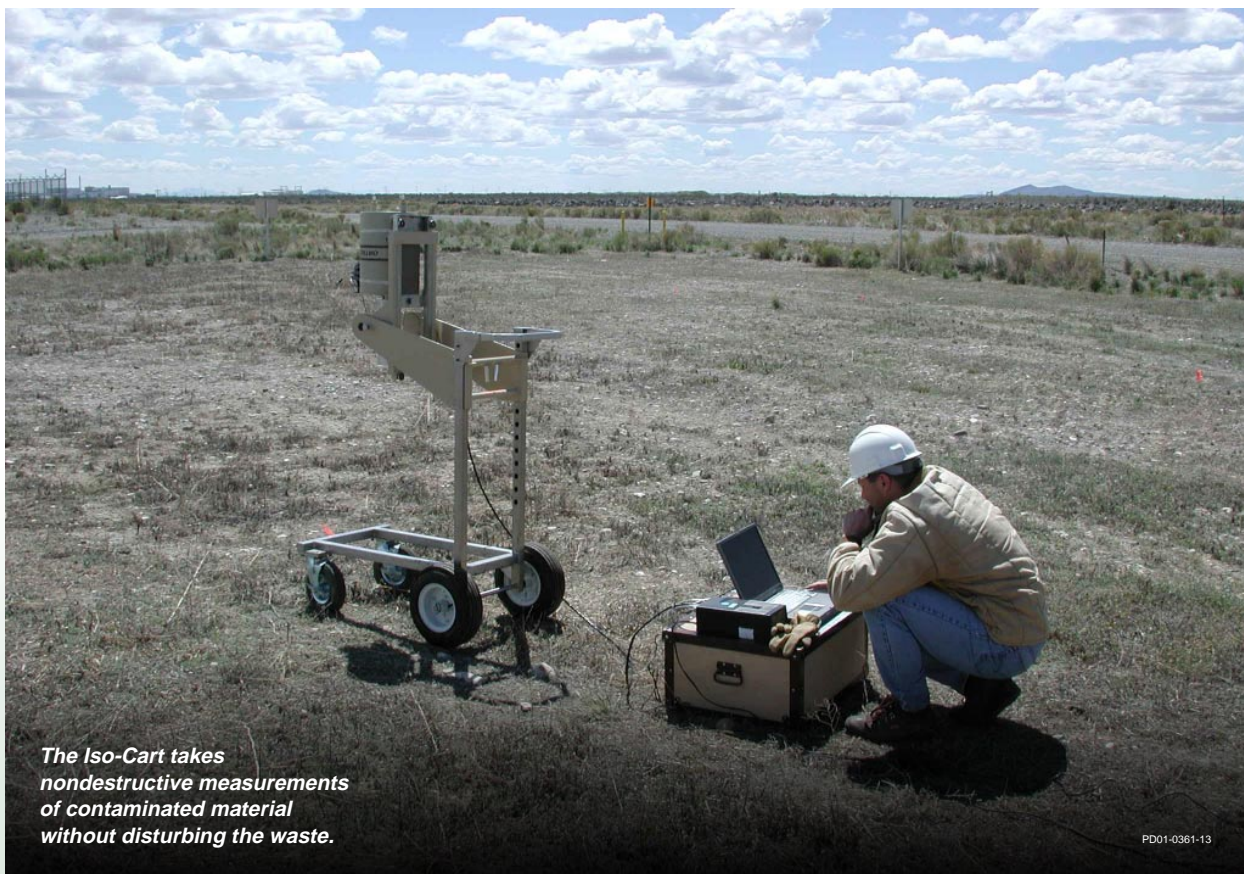
*The Iso-Cart takes nondestructive measurements of contaminated material without disturbing the waste.*

*The ISO-CART™ Gamma Spectrometer System provides an accurate method of performing in situ field gamma measurements in the soil.*

takes non-destructive measurements of contaminated material without disturbing the waste. The readings are transmitted to a laptop computer and displayed in either two- or three-dimensional maps and pictures. The adjustable cart positions the detector to obtain accurate readings. Relying on the ISO-CART's™ user-friendly features, workers can use it in a variety of situations. Because the cart holds the entire detector system and is remotely controlled, it reduces the operator's exposure to contaminated material. The **ISO-CART™ Gamma Spectrometer System** is designed for reliable operation in harsh environmental conditions and is simple to operate and easy to maneuver.

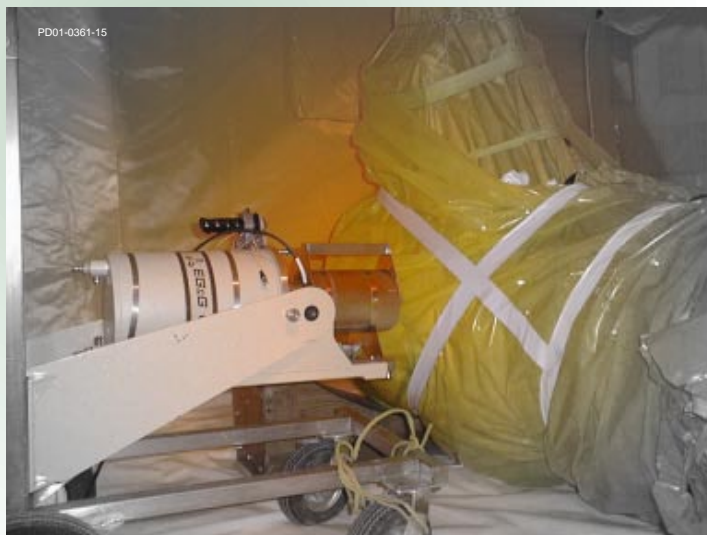
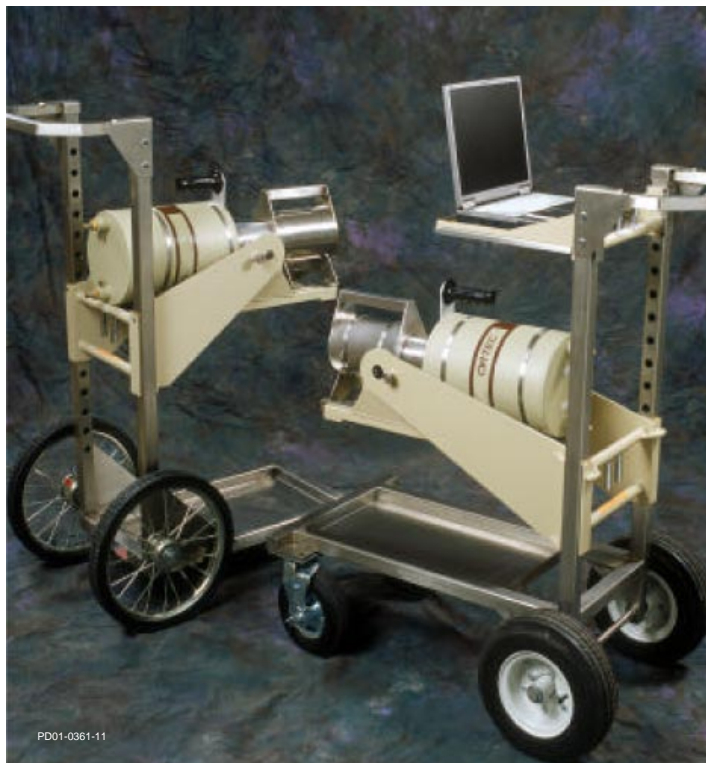
*Two versions of the Iso-Cart. The Iso-Cart used at ARA-23 is on the right.*

*Iso-Cart is confirming a suspect contamination source.*
